Kenilworth Park Landfill RI/FS Update

June 14, 2018

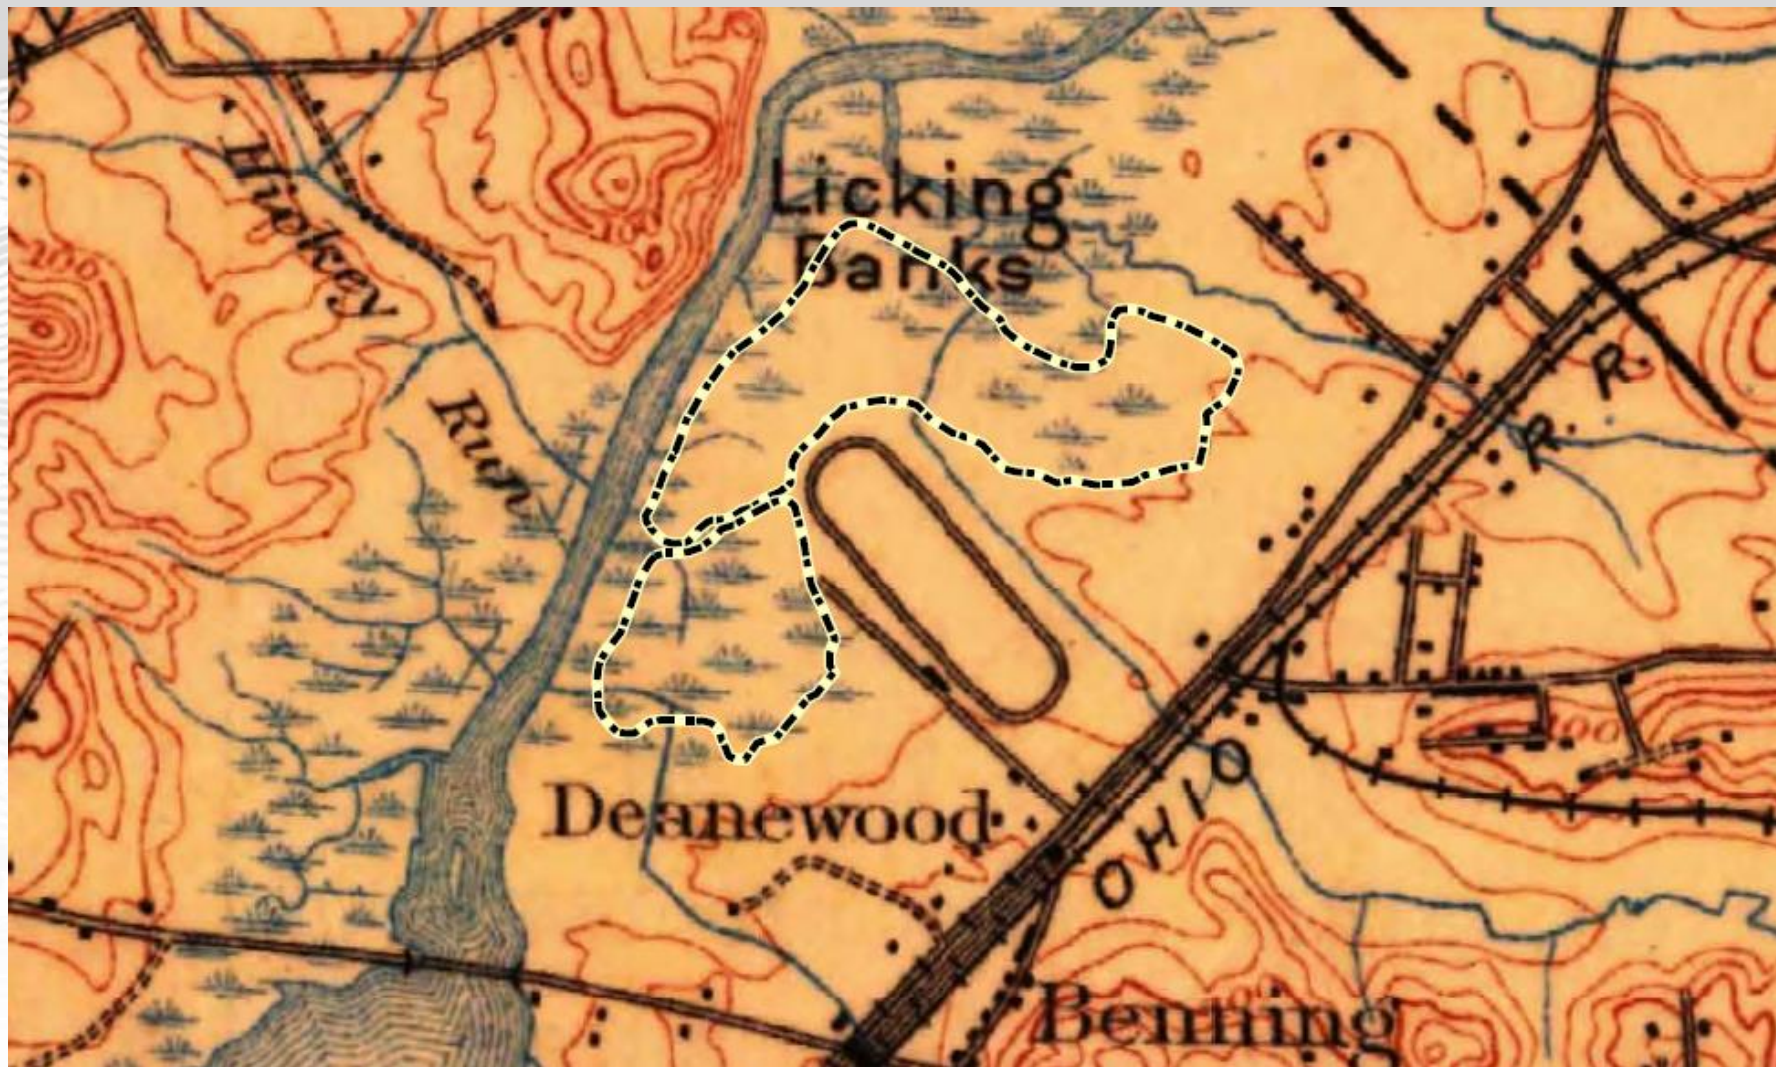
1900 USGS Map; Predevelopment

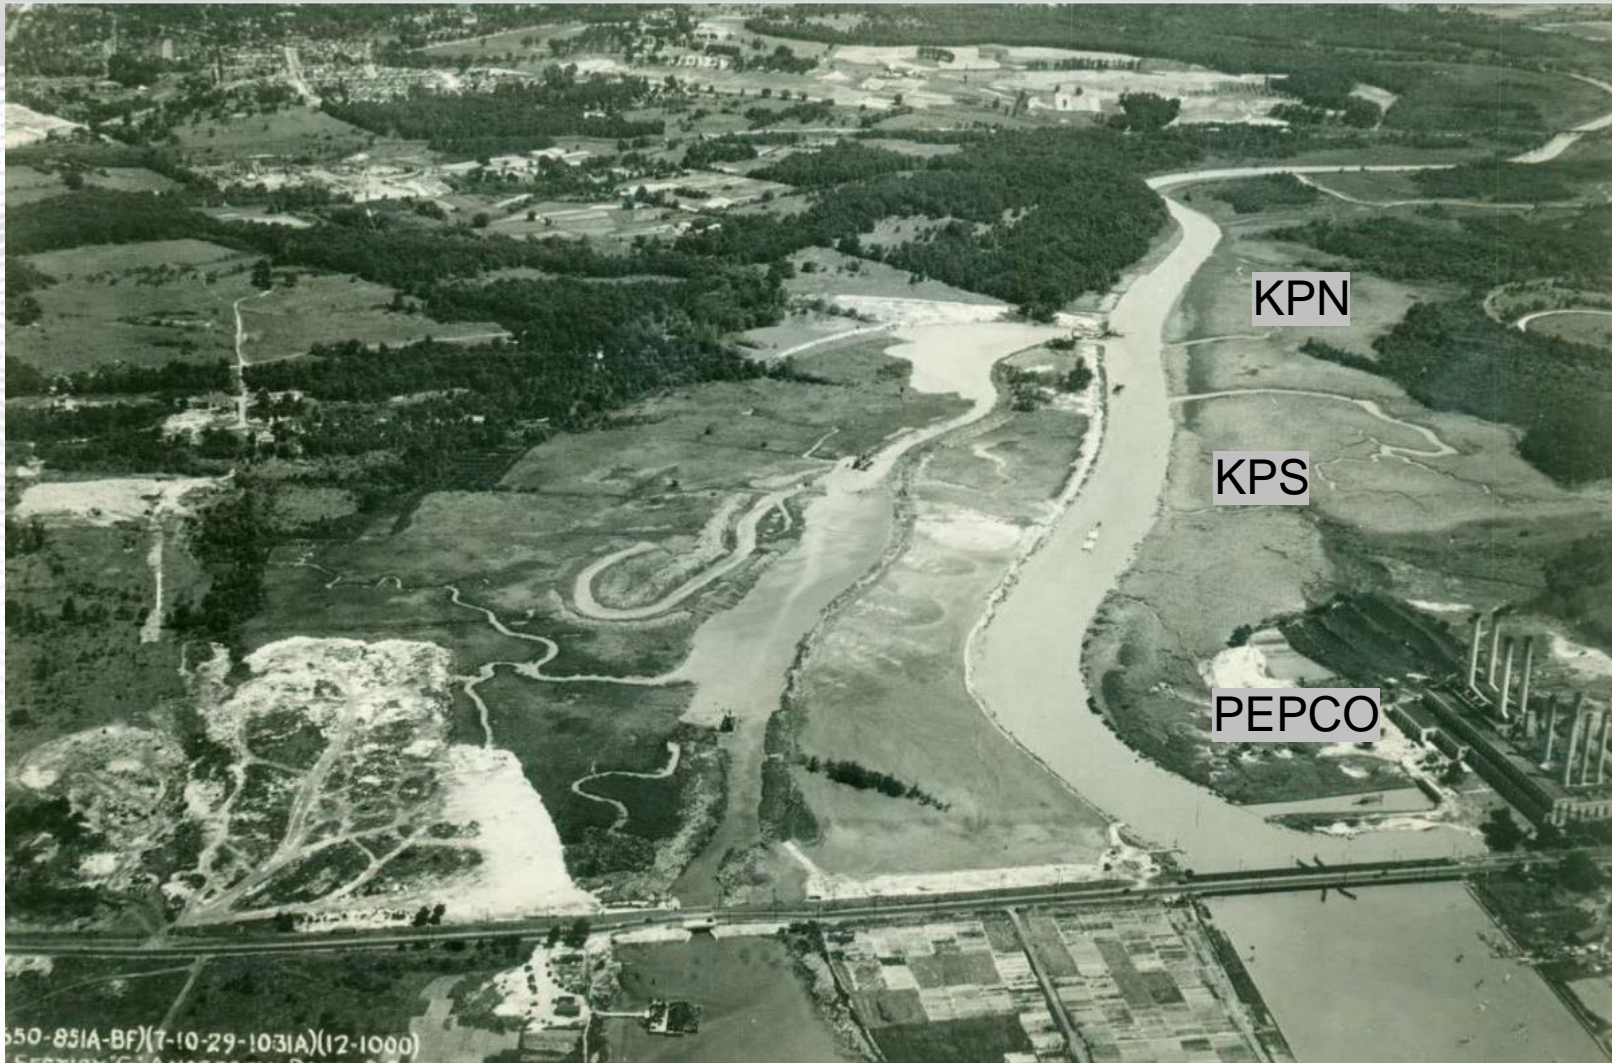
1929 Aerial Photo; Predevelopment

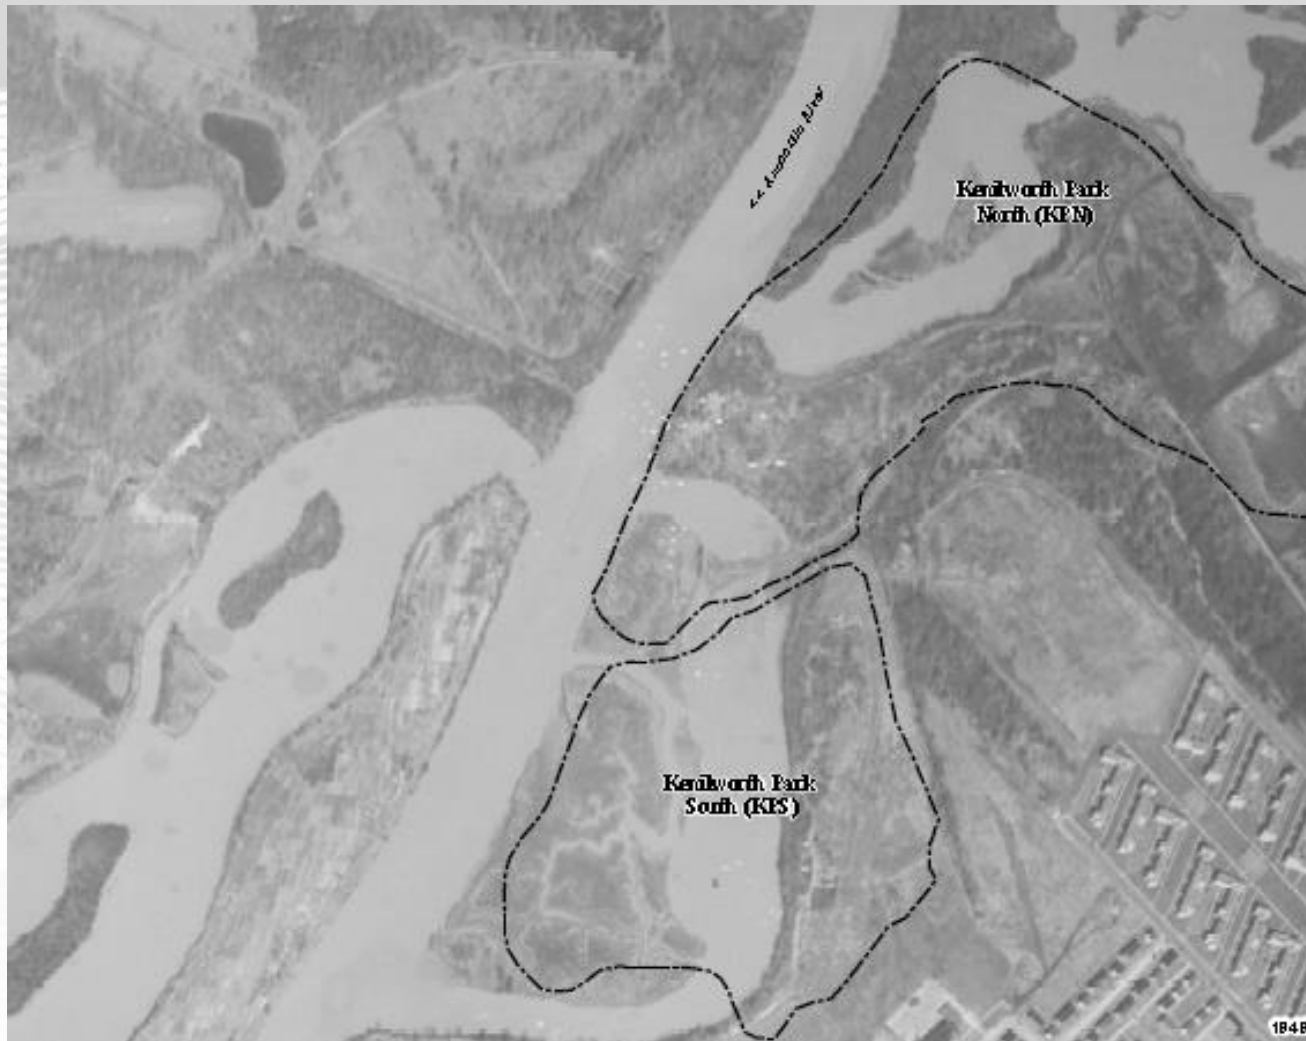
1949 Aerial Photo; Fill Progression

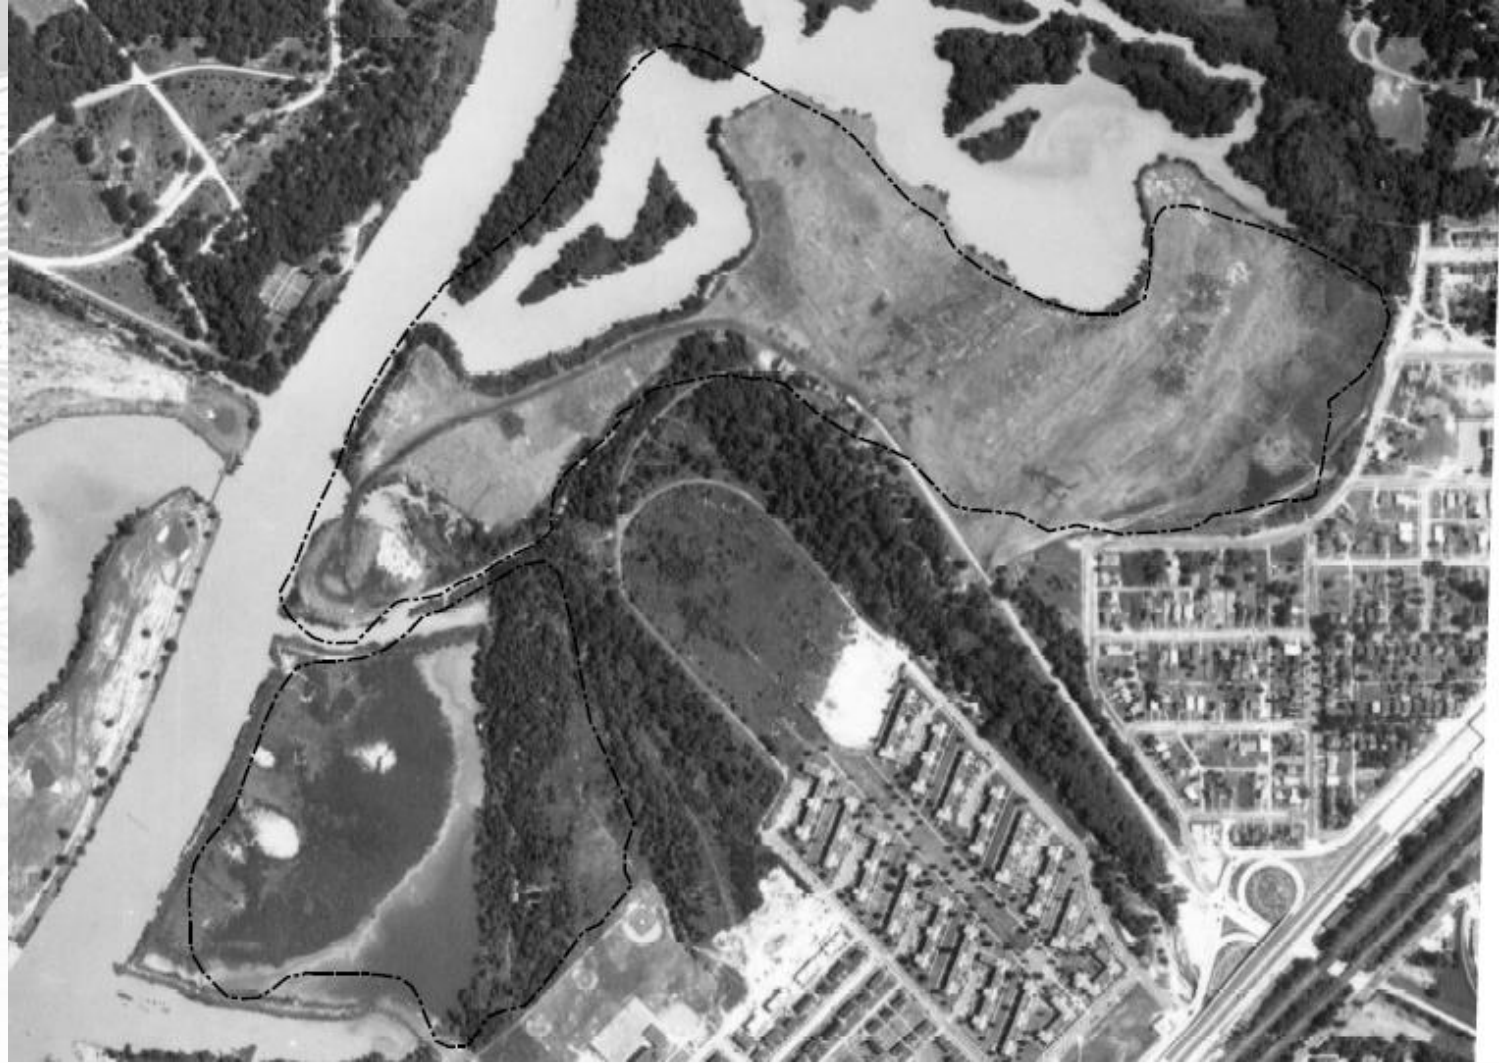
1957 Aerial Photo: Fill Progression

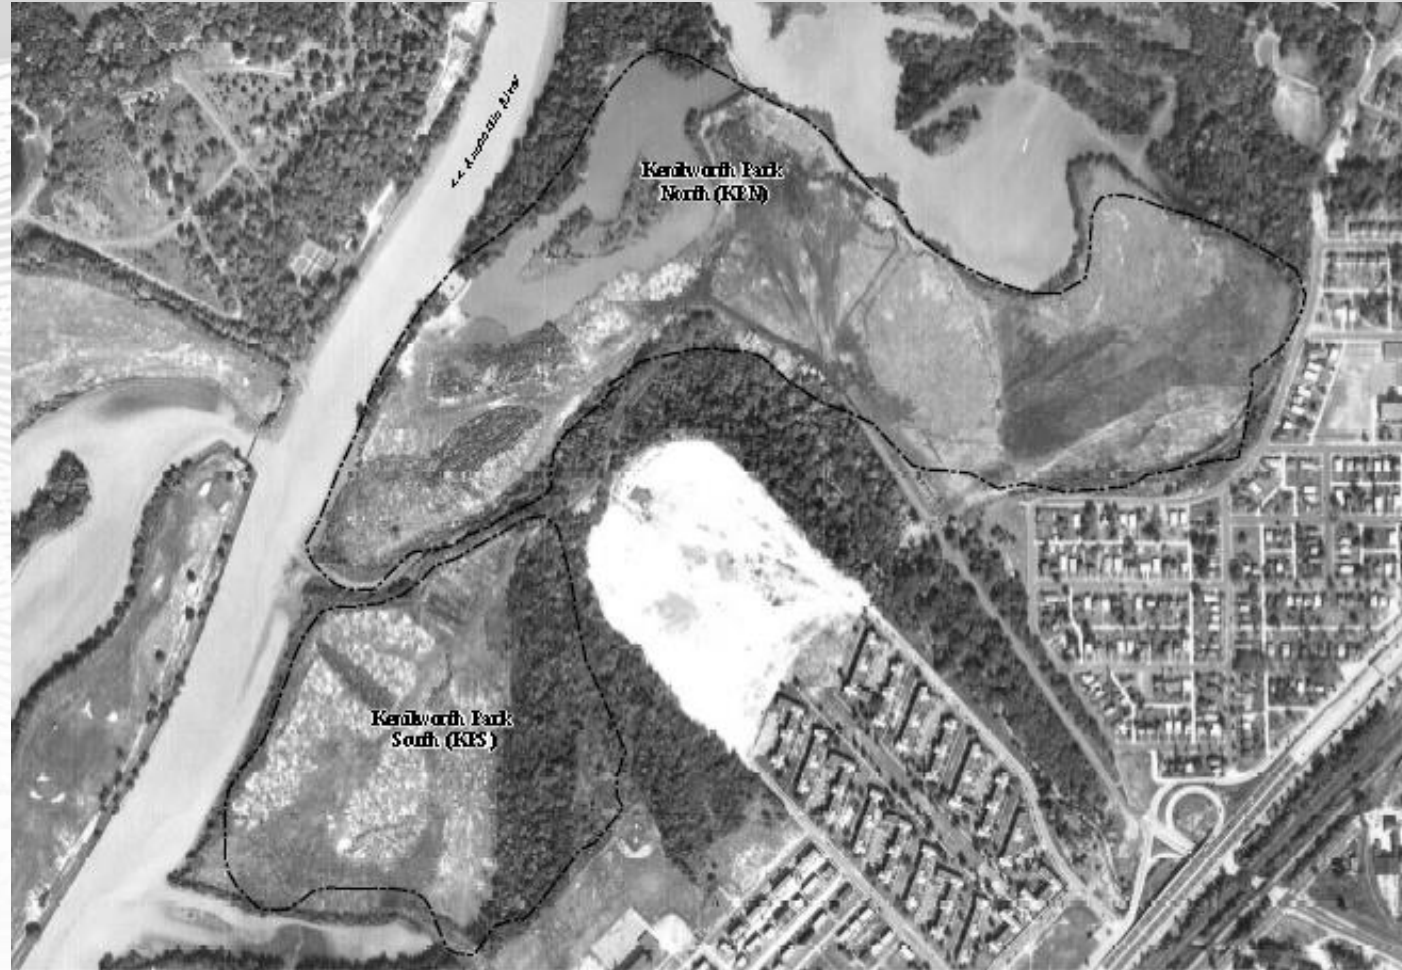
1963 Aerial Photo; Fill Progression

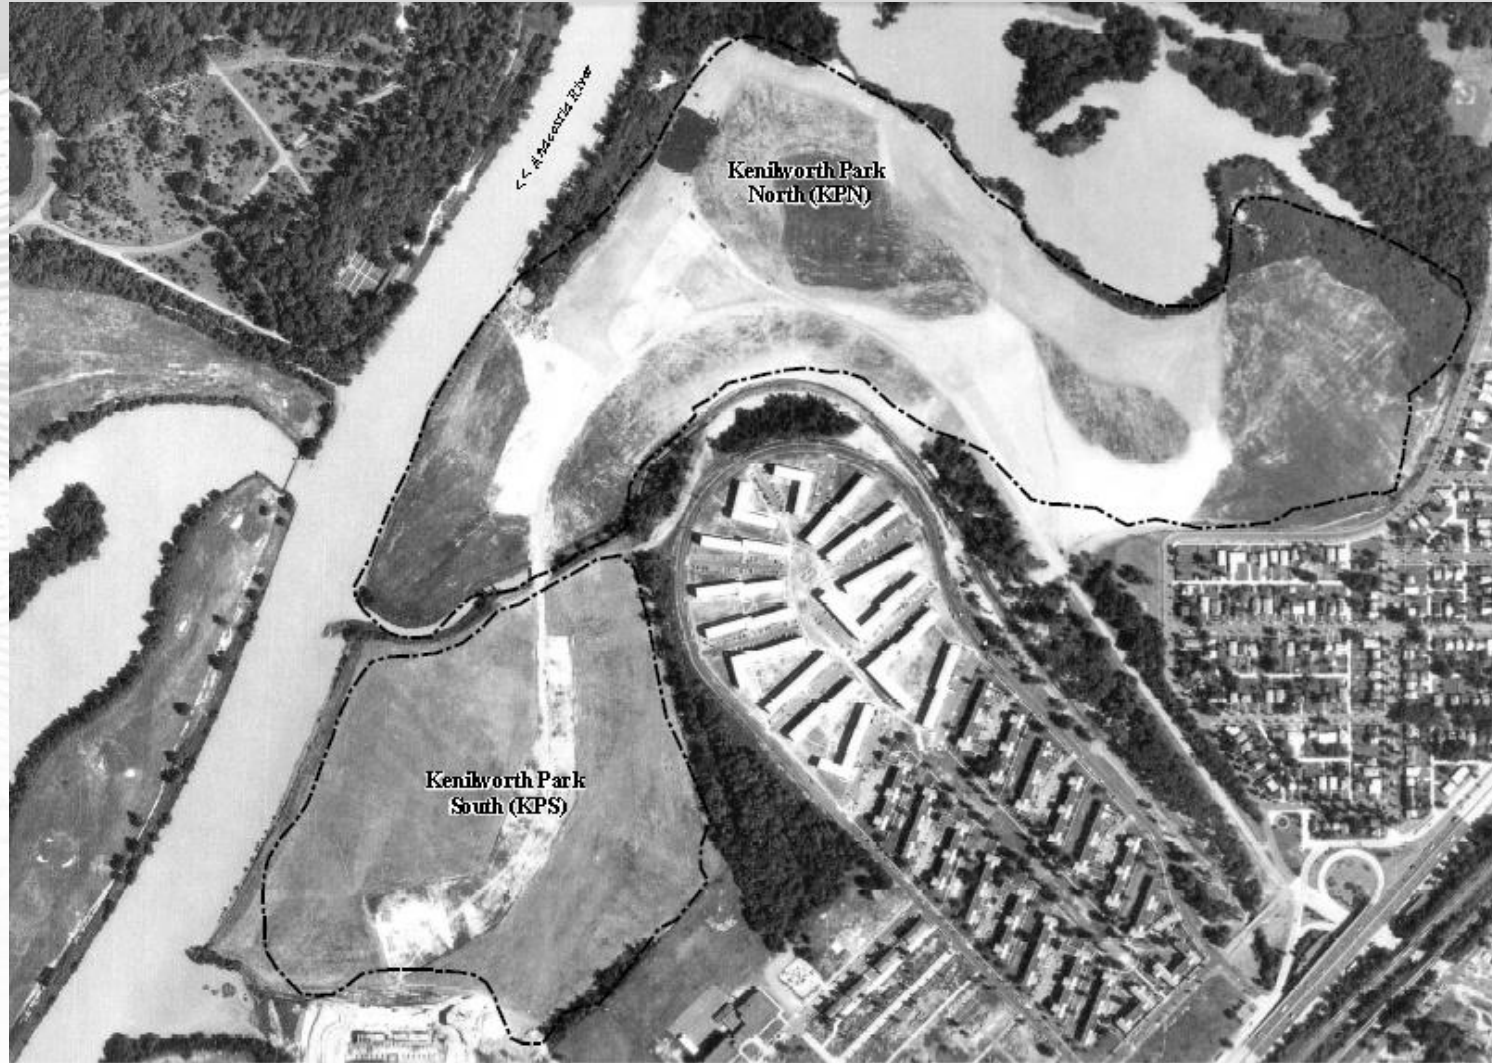
1970 Aerial Photo; Landfill Closure

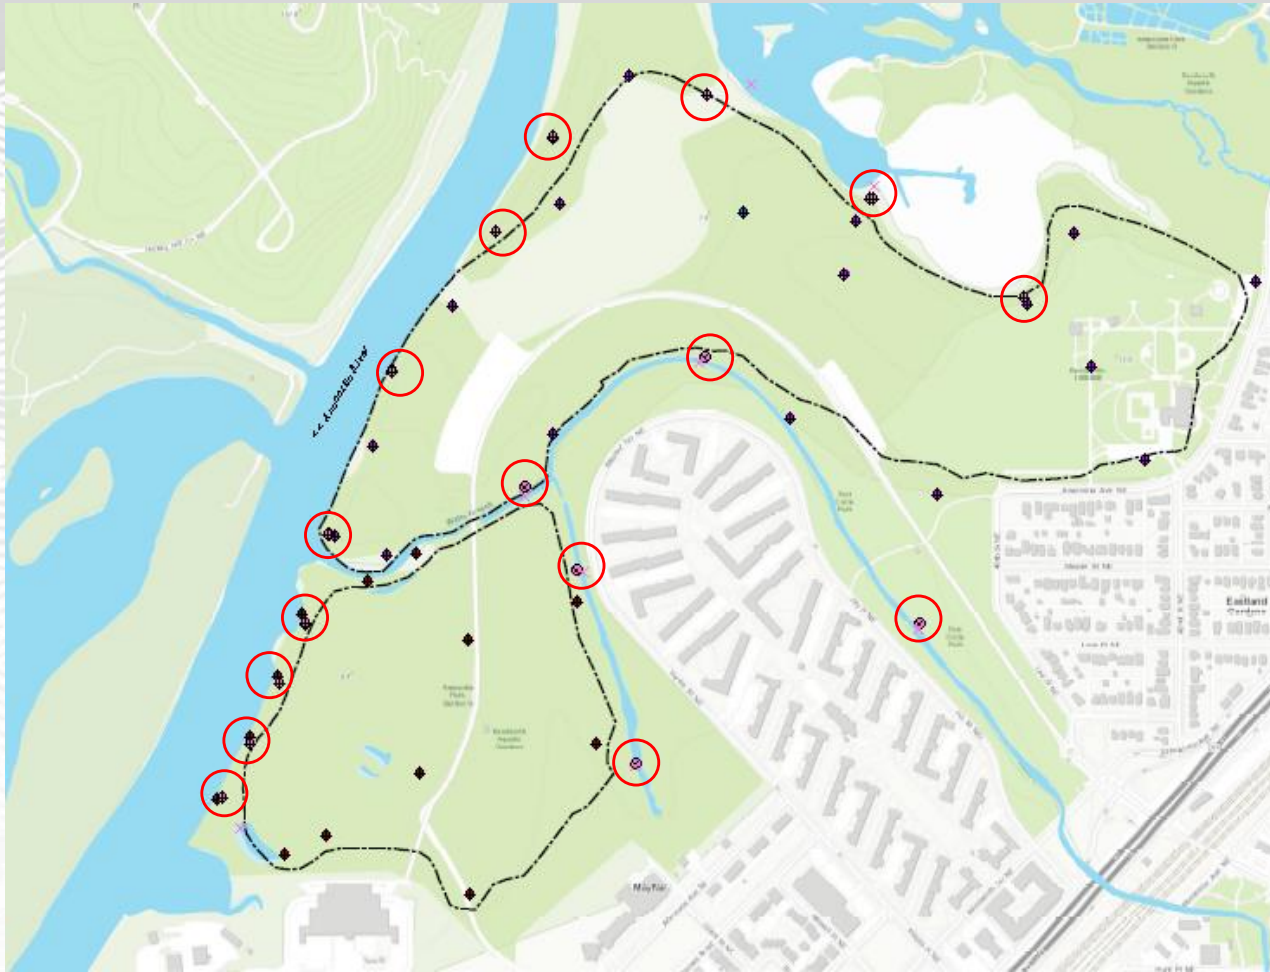
2013/2014 SGS

20 New Monitoring Wells

11 Locations

5 Replacement Wells

9 Shallow and Deep “Couplet” Wells

5 Shallow and Deep Couplet Piezometers

- **No PCBs detected**
- **Relatively low concentrations of a few VOCs, PAHs, and dioxins in a small subset of wells**
- **No evidence of concentrated contaminant plume or source zone**
- **VOCs, PAHs, dioxins not considered a significant migration threat**
- **Several metals detected above screening levels in multiple locations**
- **Further assessment of metals in porewater recommended**

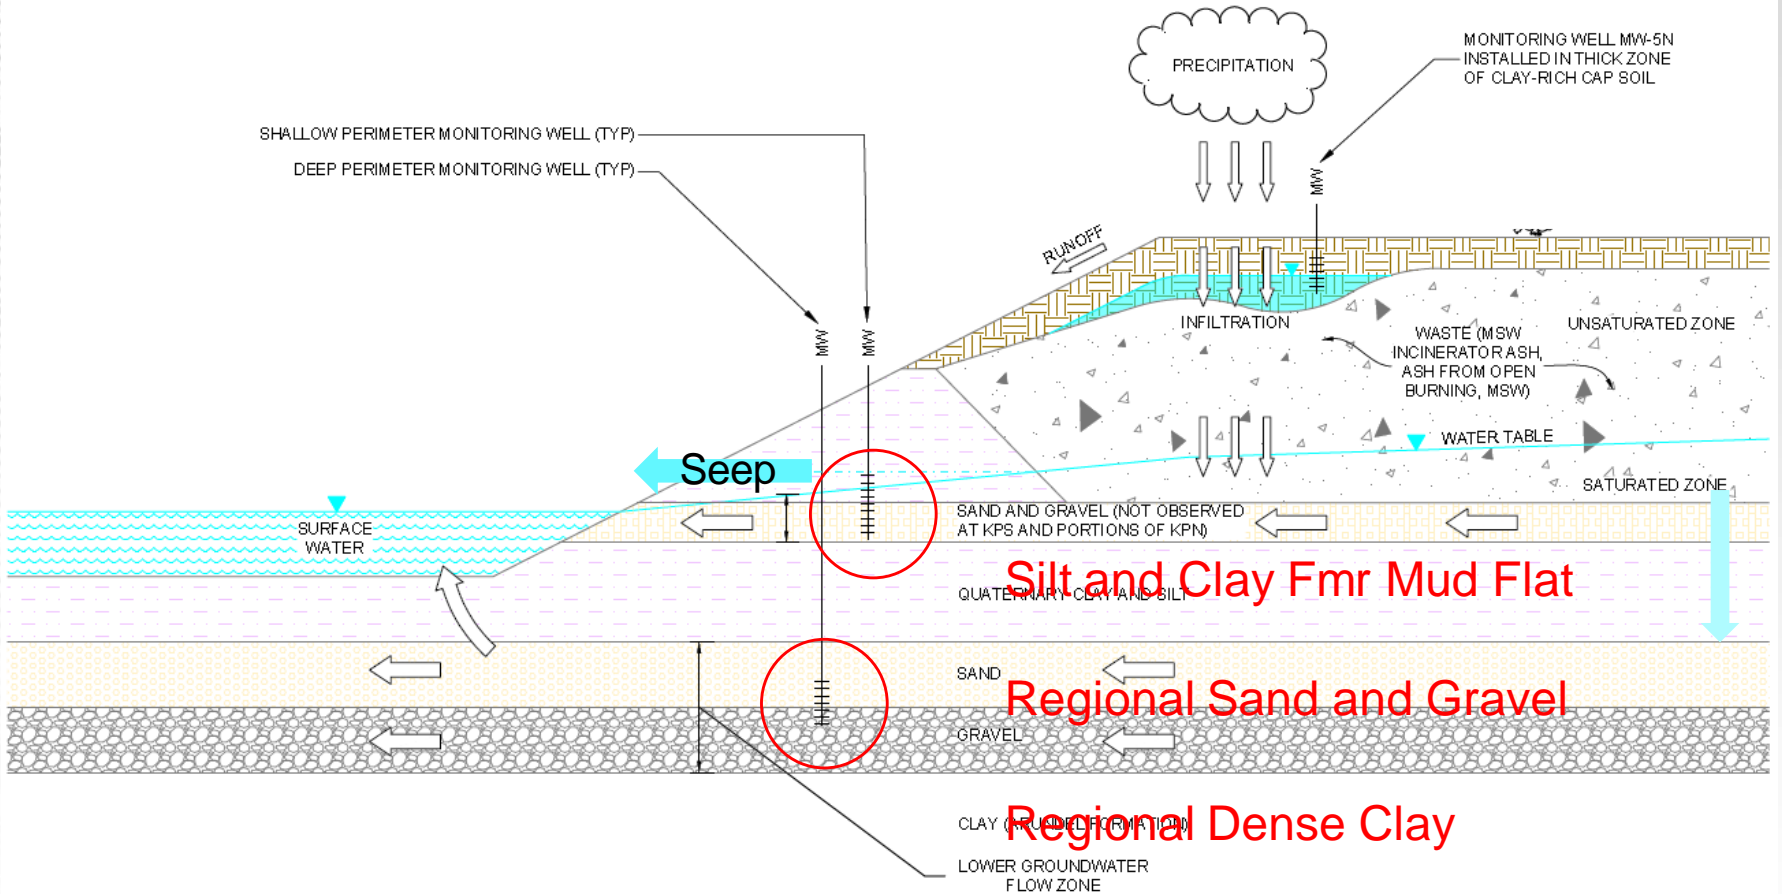
Graphical CSM – Not to Scale

KPN = KENILWORTH PARK NORTH LANDFILL AREA
KPS = KENILWORTH PARK SOUTH LANDFILL AREA
